# **Assessment of Dam Safety of Coal Combustion Surface Impoundments**

**Indianapolis Power & Light Company**

**Petersburg Generating Station**

**November 15, 2010**

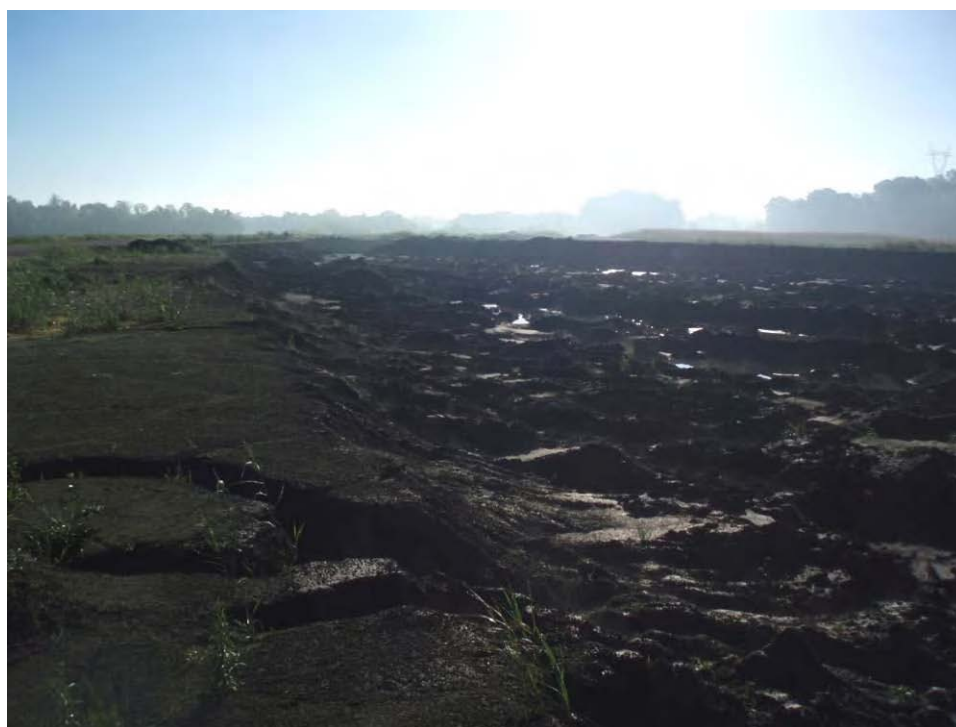
104. Overview of Pond C from northeast corner, looking east.

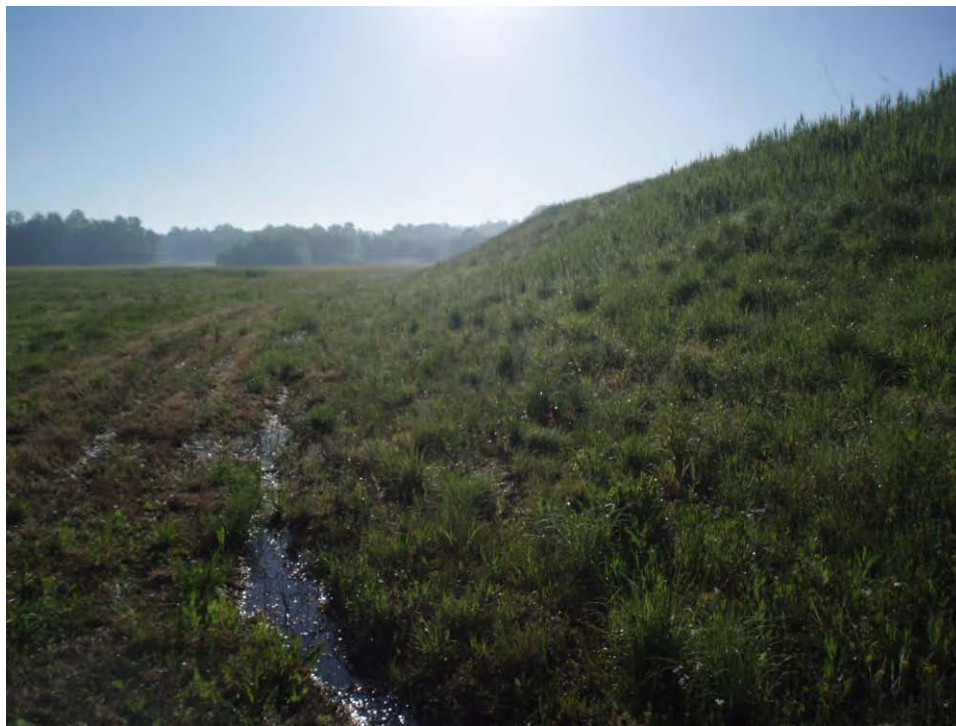
105. Pond C - West embankment lower exterior slope, looking northeast.

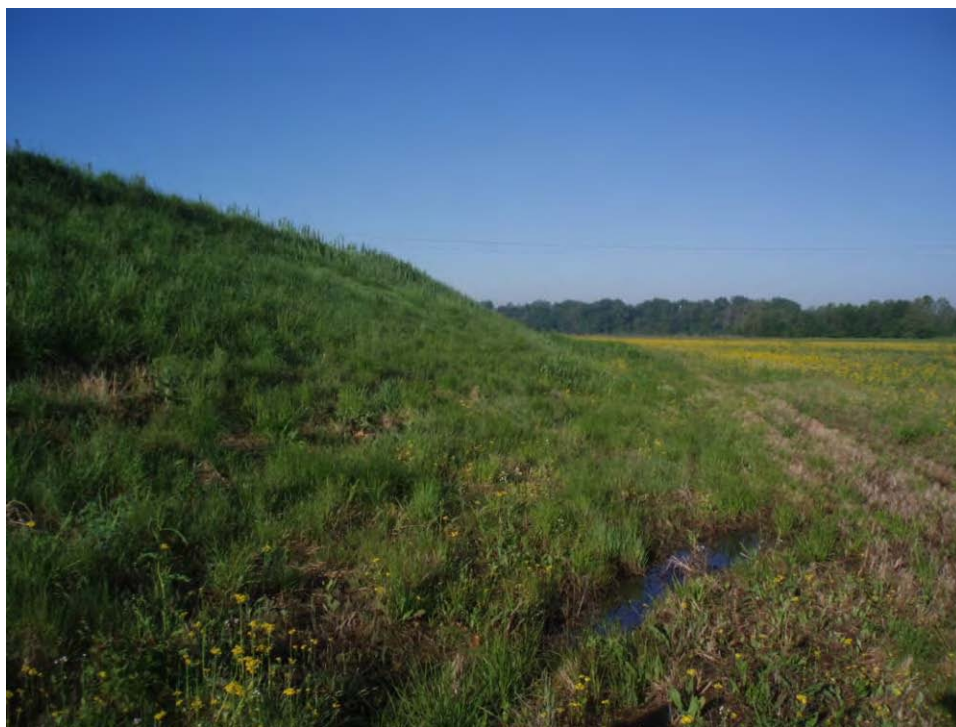
106. Pond C - West Embankment lower exterior slope, looking southwest.

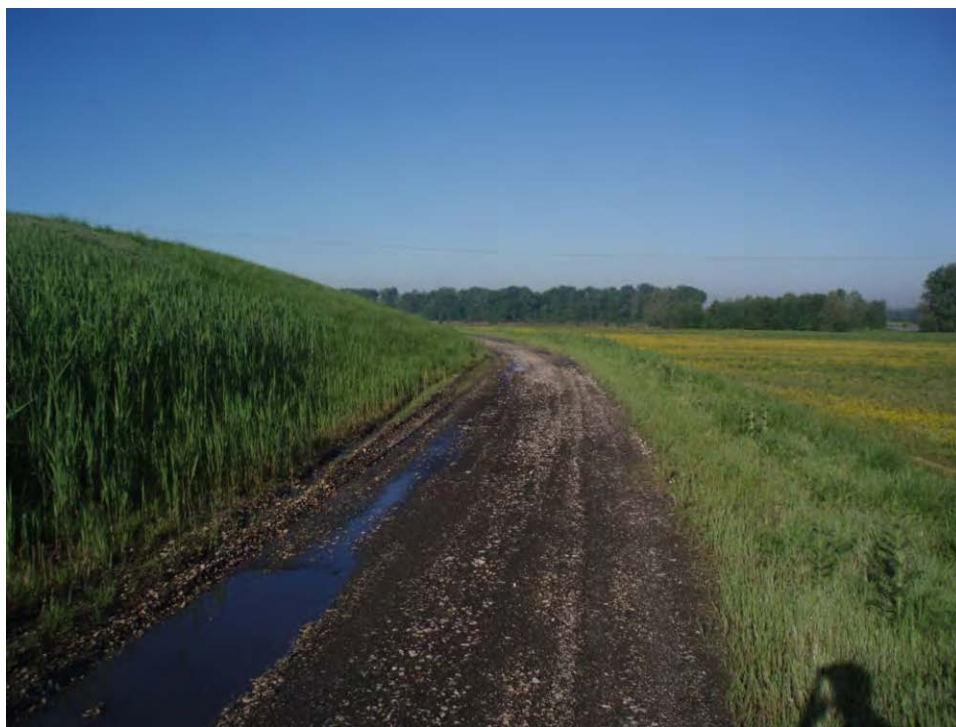
108. Pond C – West embankment bench, looking southwest.

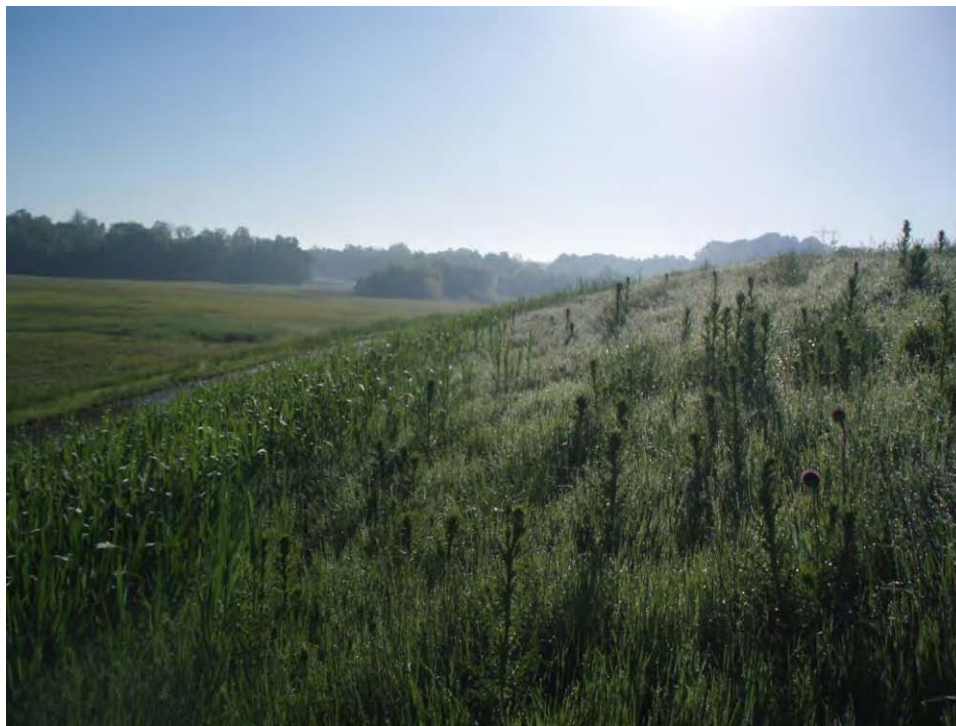
109. Pond C – West embankment upper exterior slope, looking northeast.

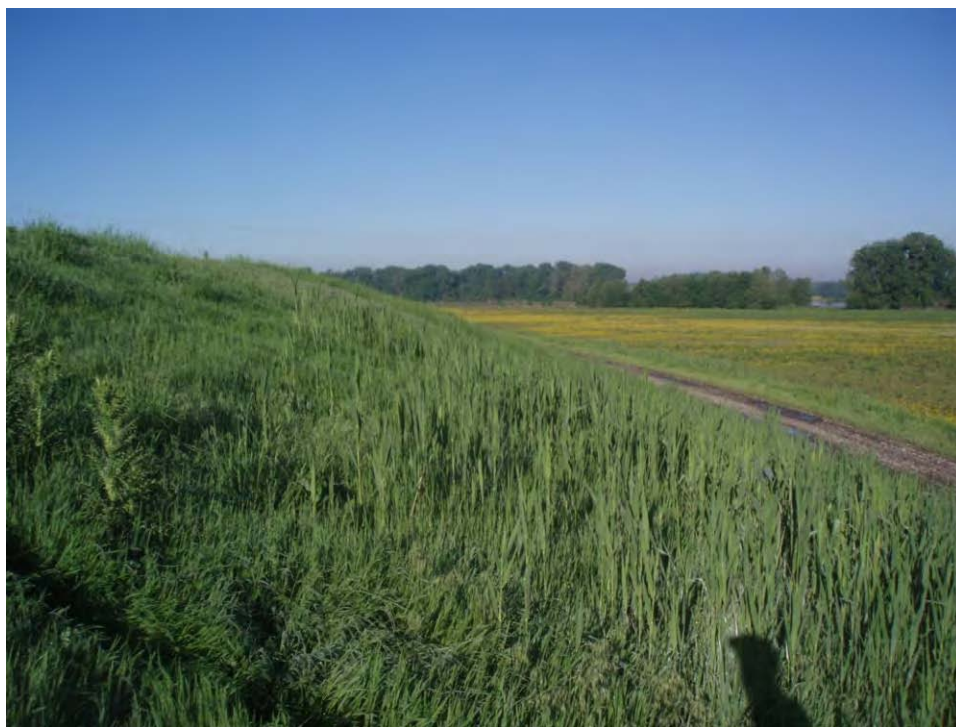
110. Pond C – West embankment upper exterior slope, looking southwest.

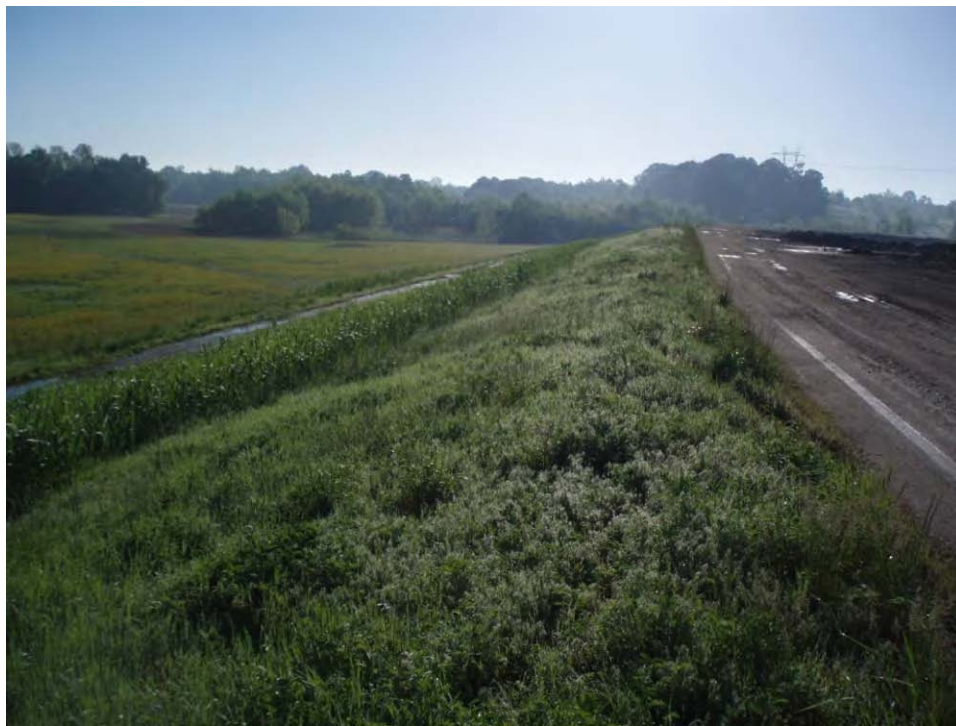
111. Pond C – West embankment crest, looking east.

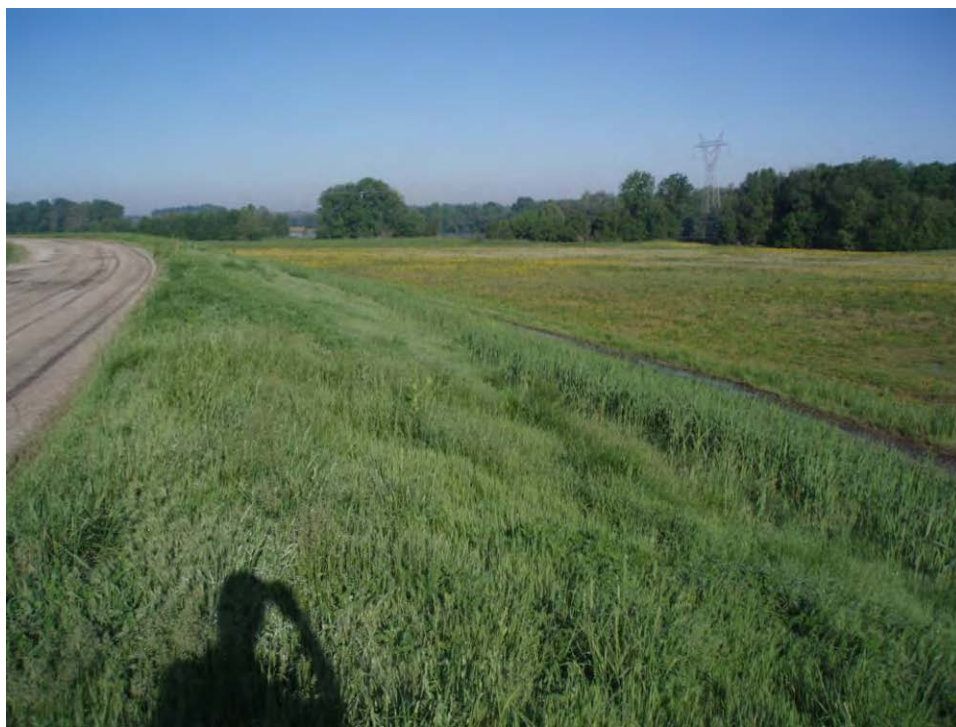
112. Pond C – West embankment crest, looking west.

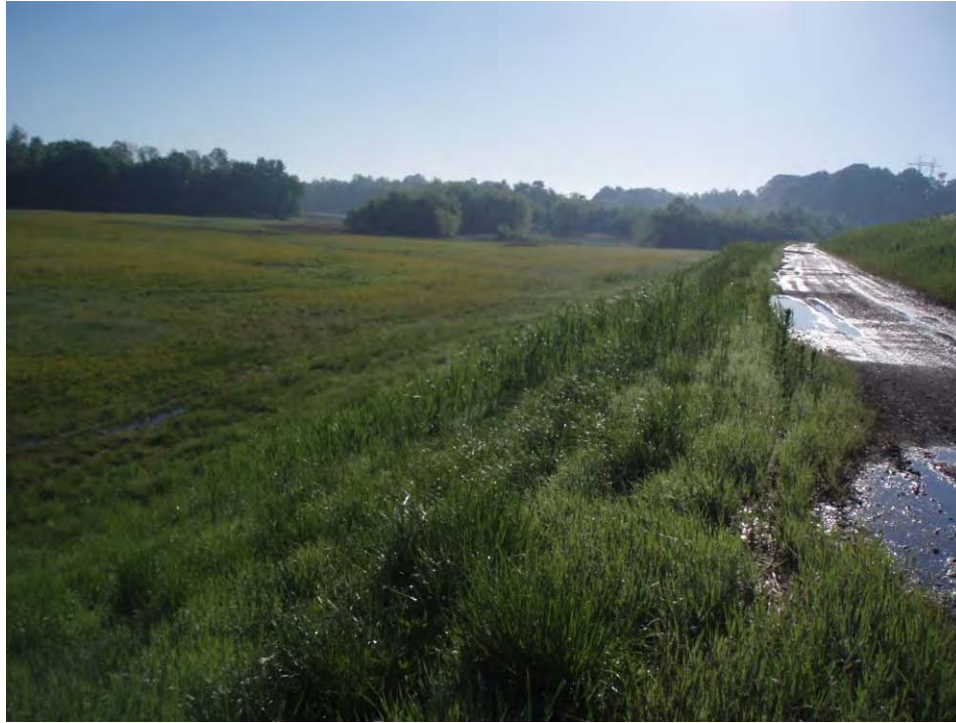
113. Pond C – West embankment bench, looking east.

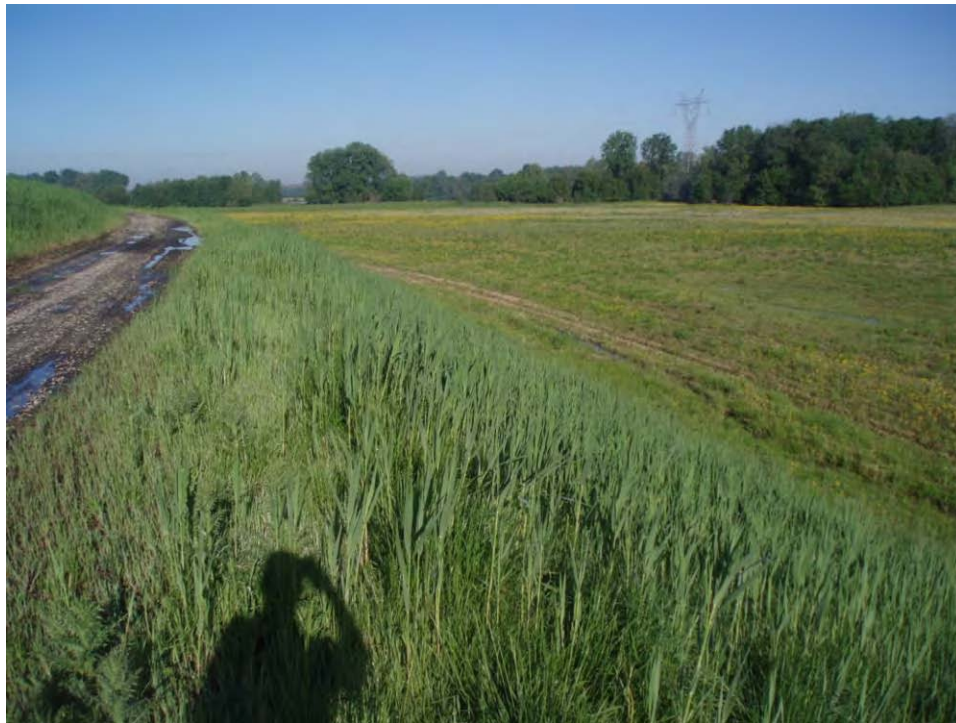
114. Pond C – Wes embankment bench, looking west.

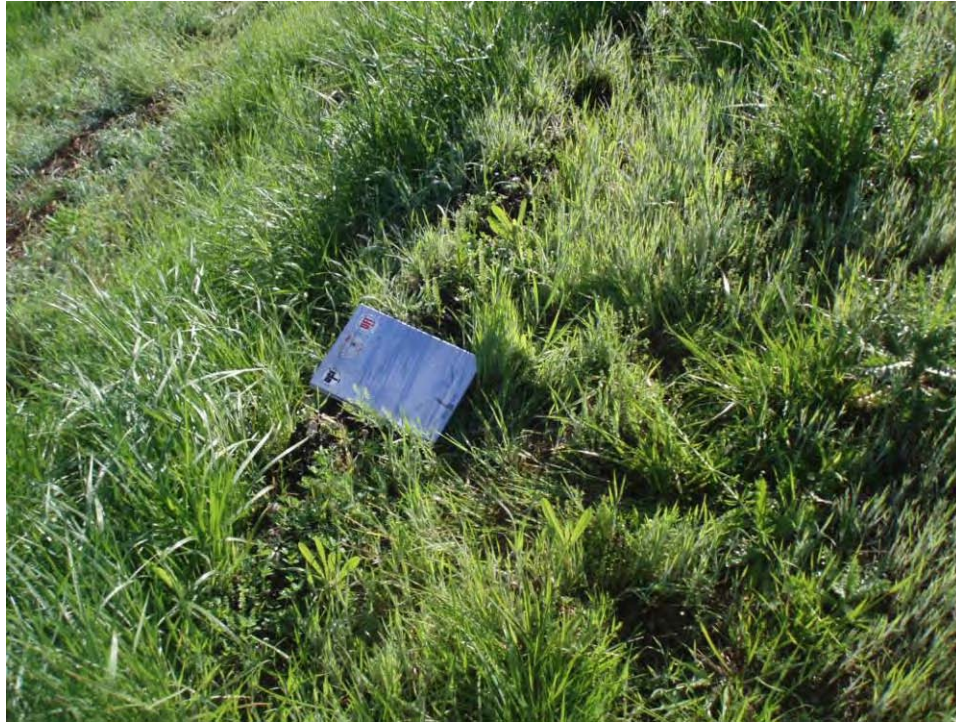
115. Pond C - West embankment lower exterior slope, looking at over-steepened area and tractor rutting at bench.

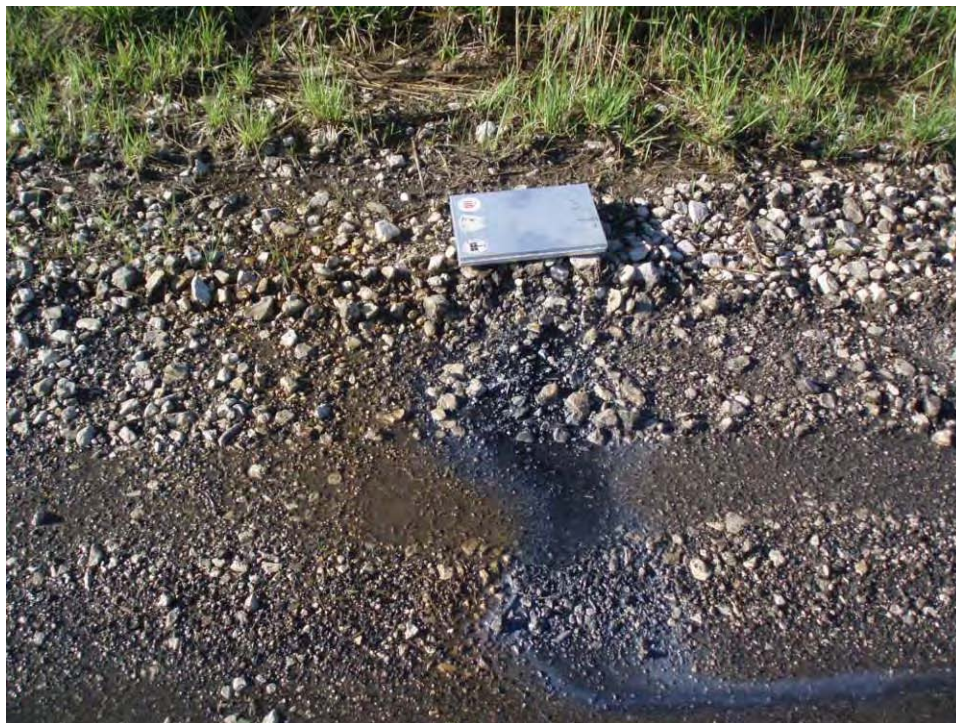
20. Outlet was obscured by thick vegetation.	
21. Seepage around perimeter of embankment at toe of vertical expansion from El. 440 to El. 455. Sporadic white and black clouding and iron staining in seepage water.

116. Pond C - West embankment bench, looking at active seepage located at toe of upper exterior slope. Note the white and black sheen in the water.

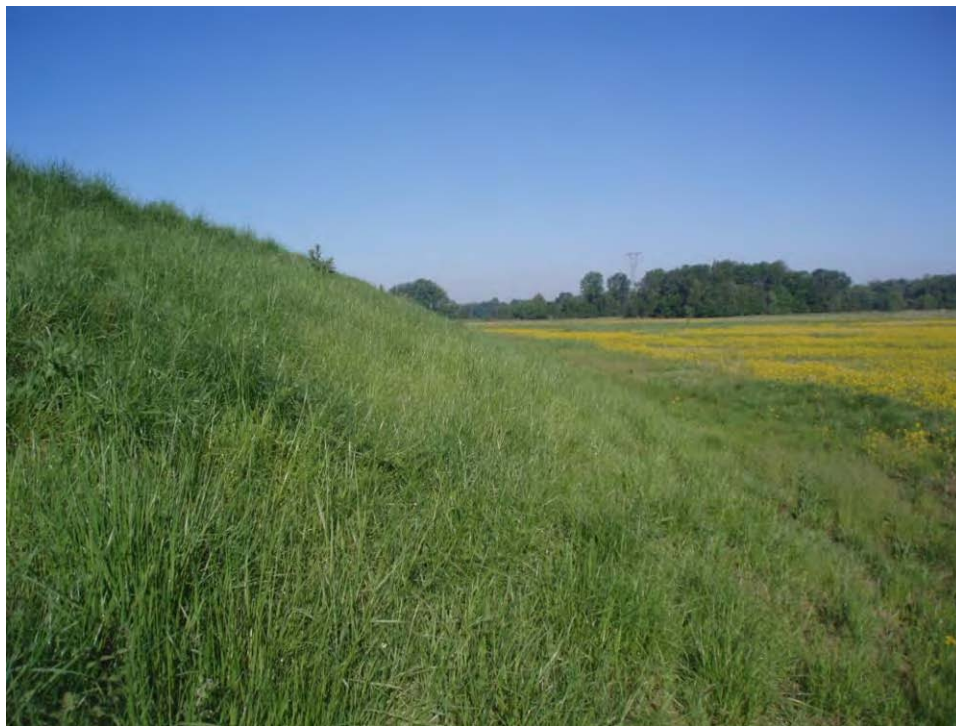
117. Pond C - West embankment lower exterior slope, looking west.

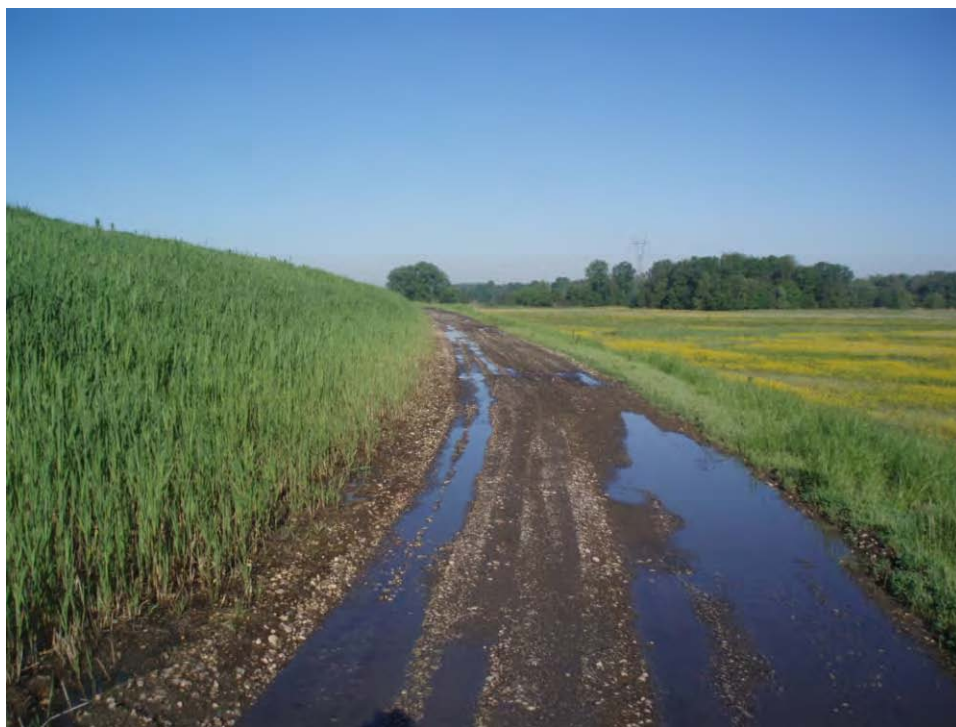
118. Pond C - West embankment bench, looking west.

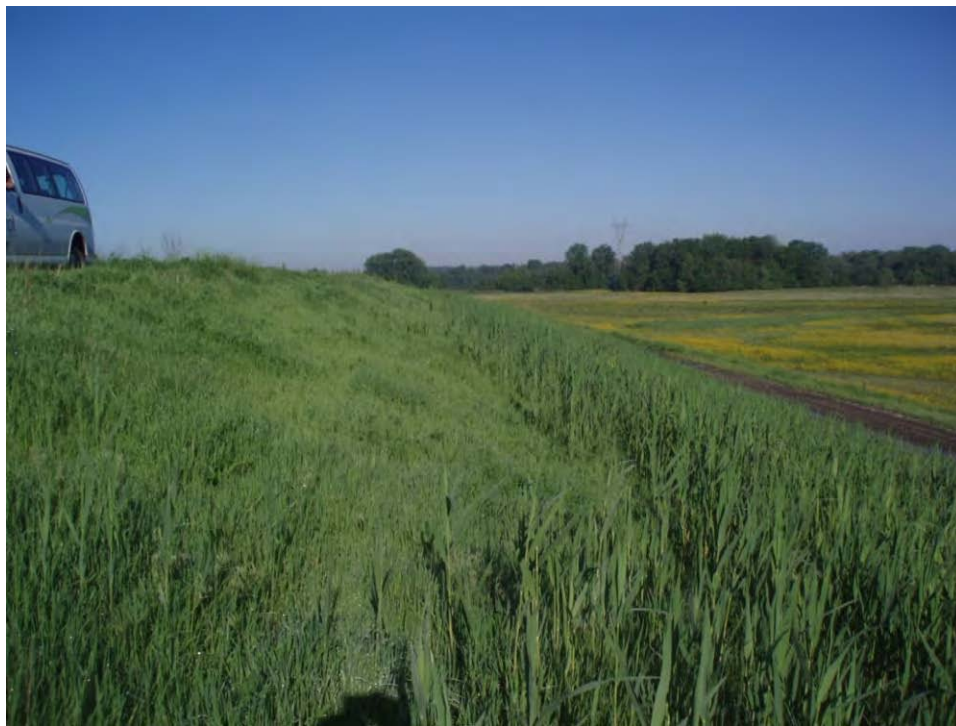
119. Pond C – West embankment upper exterior slope, looking west.

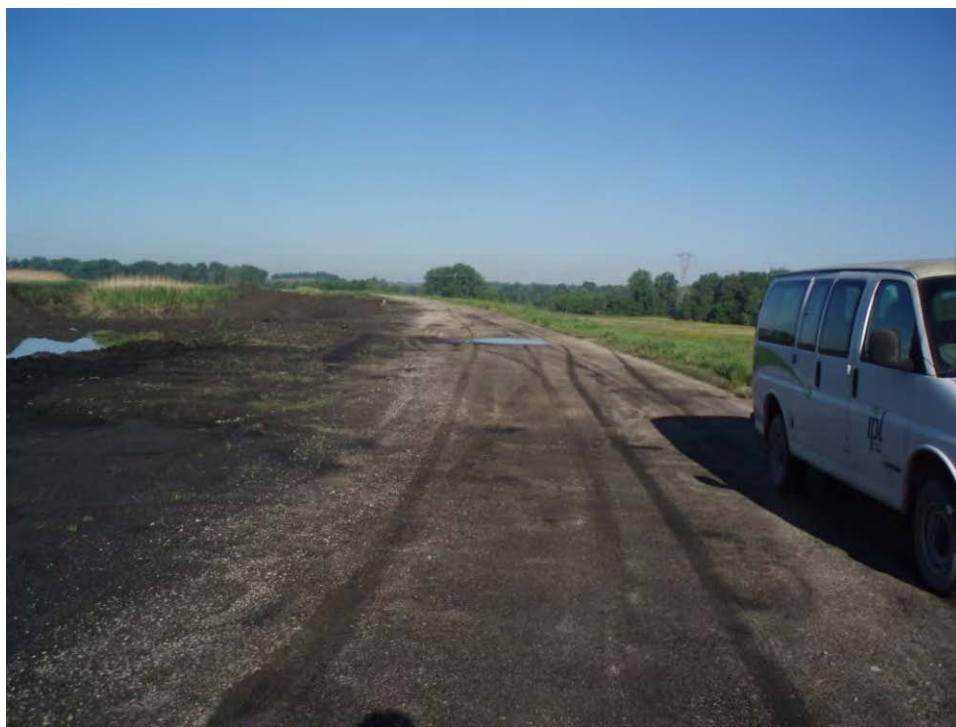
120. Pond C – West embankment crest, looking west.

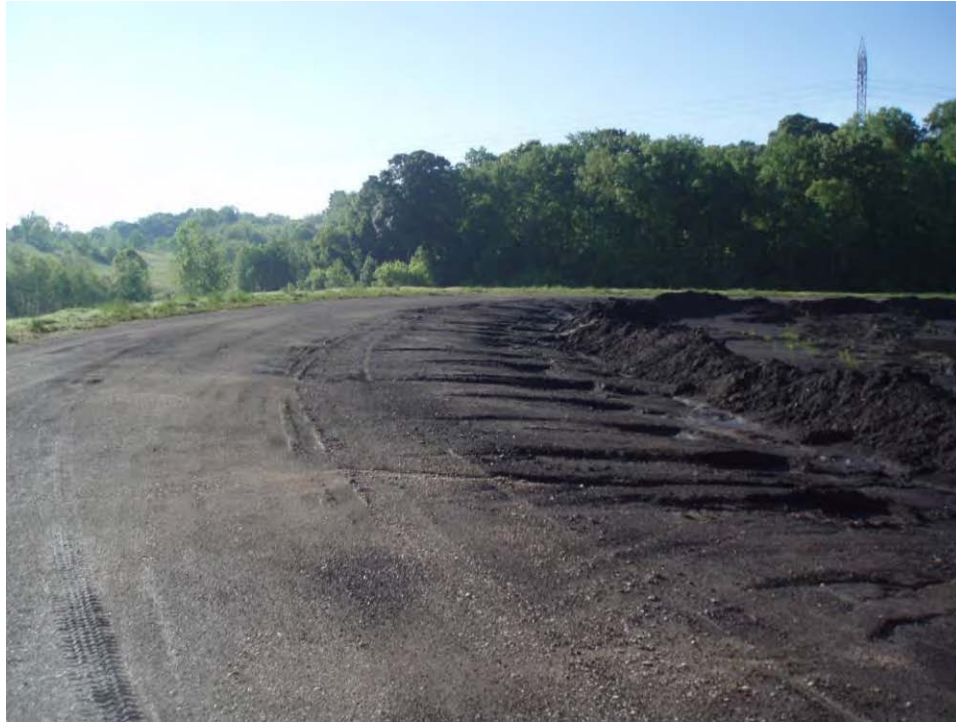
121. Pond C – North embankment crest, looking southeast.

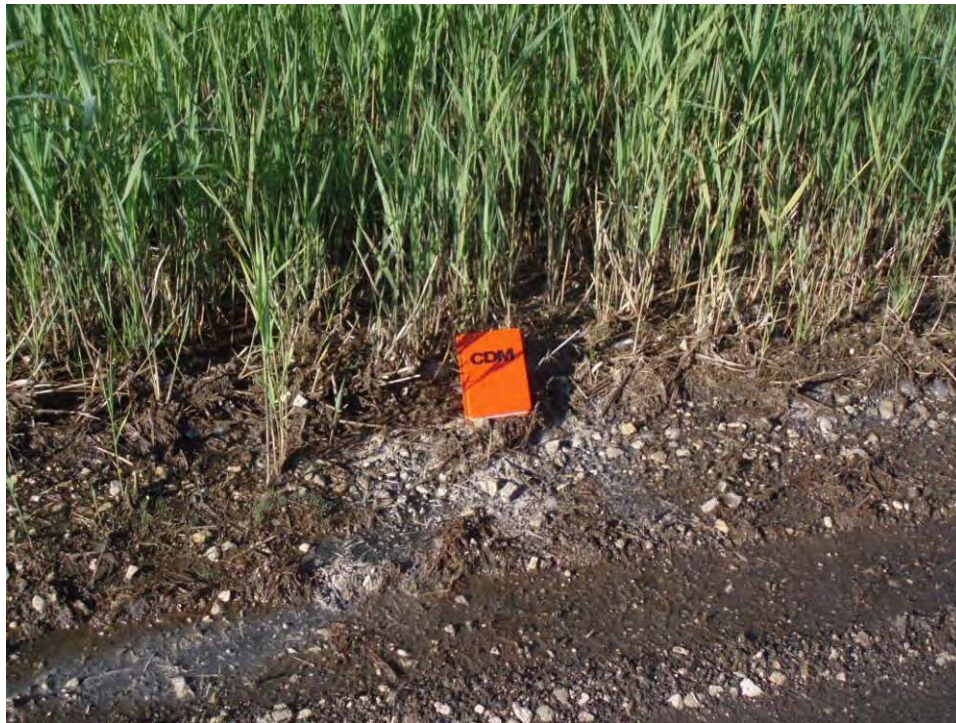
122. Pond C – North embankment bench, looking at active seepage located at toe of upper exterior slope. Note the white sheen in the water.

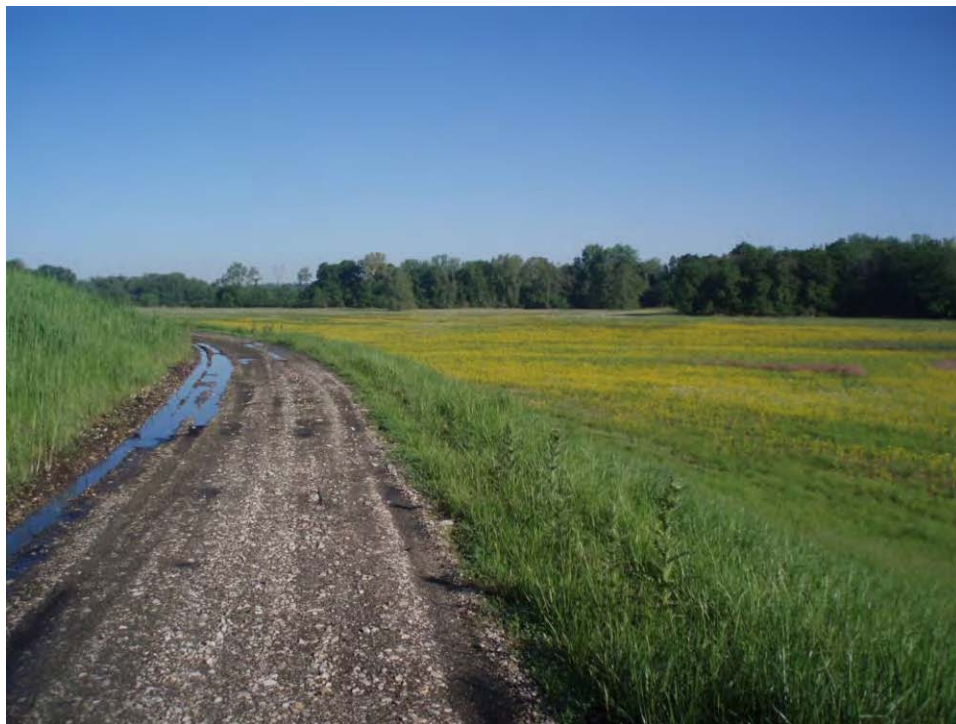
123. Pond C – North embankment bench, looking northwest.

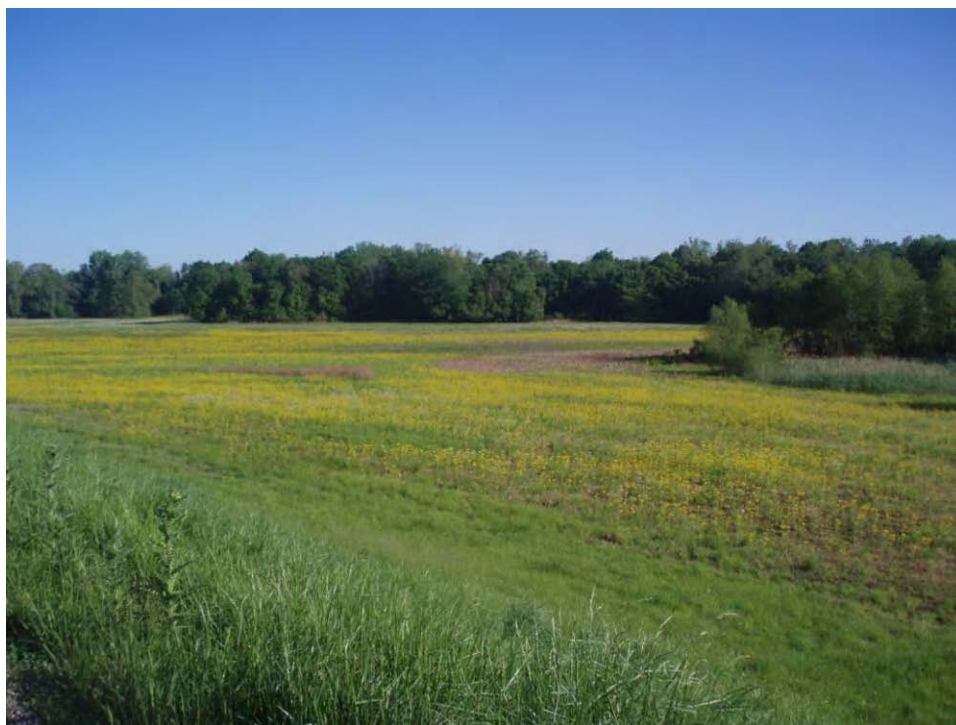
124. Pond C – North embankment, looking north at downstream area.

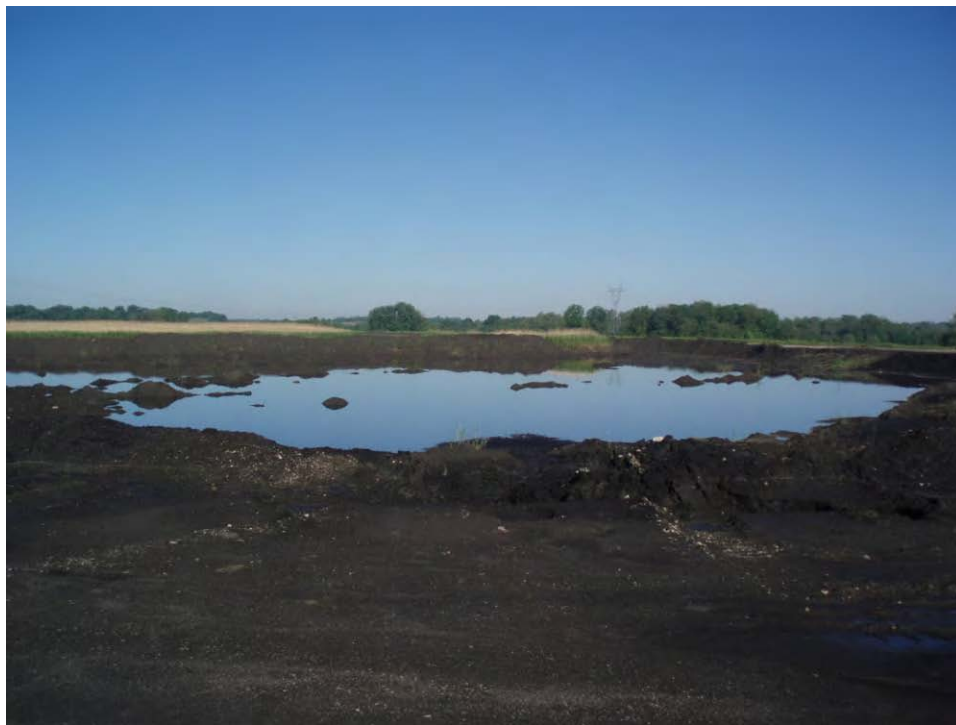
126. Overview of Pond C from northeast corner, looking northwest.

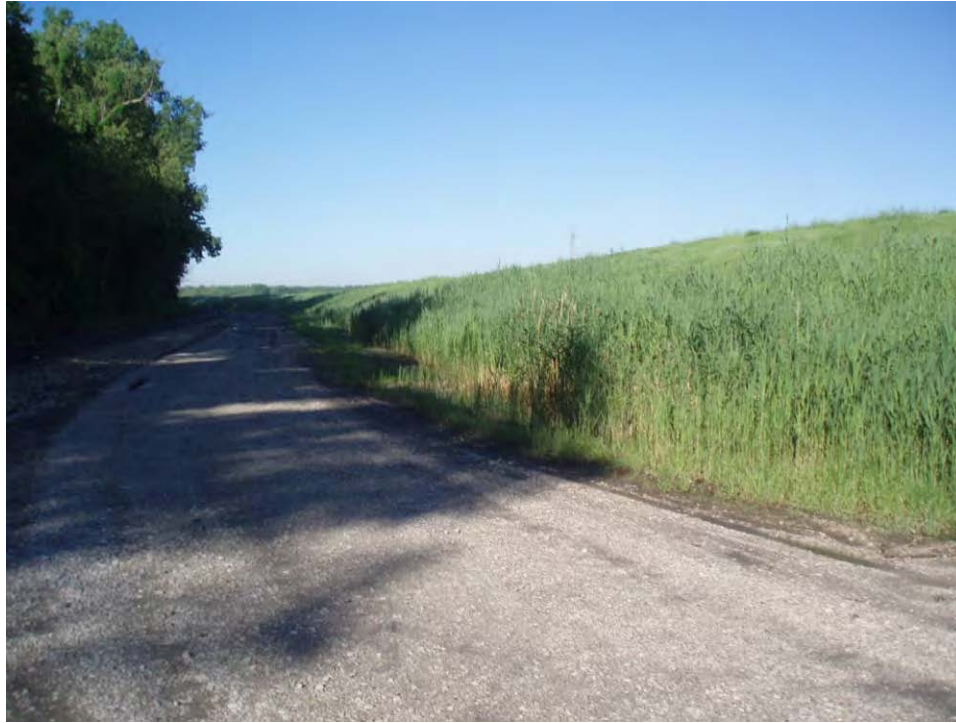
127. Pond C - East embankment exterior slope and drainage ditch, looking southwest. Note water level in drainage ditch approximately 1.5' below roadway and 5'-8' tall vegetation on lower portion of the slope extending from northern corner to access ramp. Slope at drainage ditch is over-steepened.

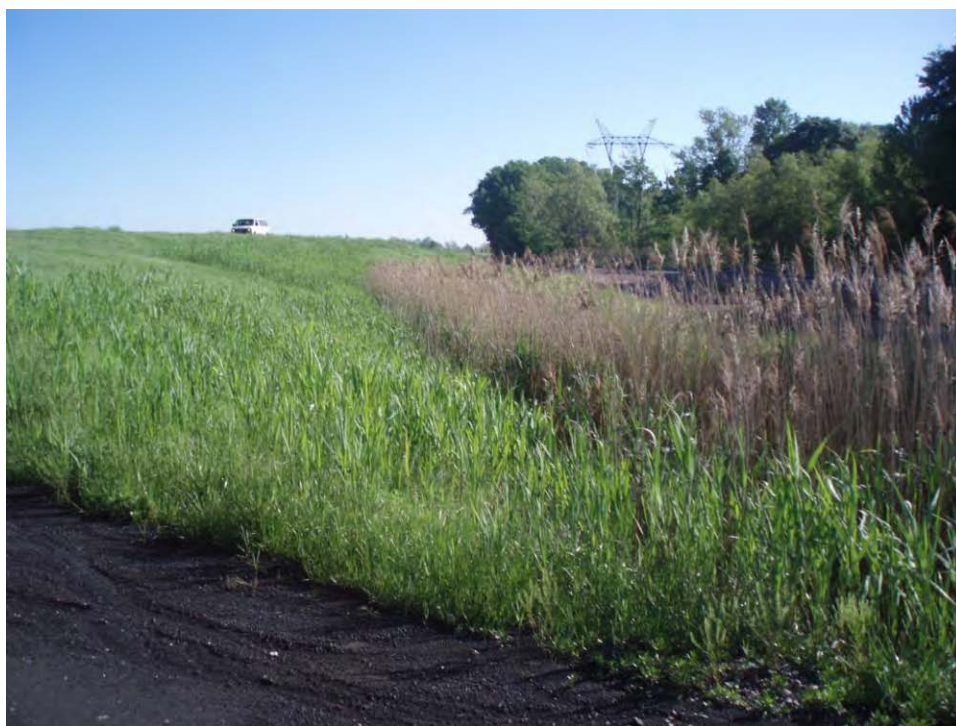
130. Pond C – East embankment exterior slope and drainage ditch, looking northeast.

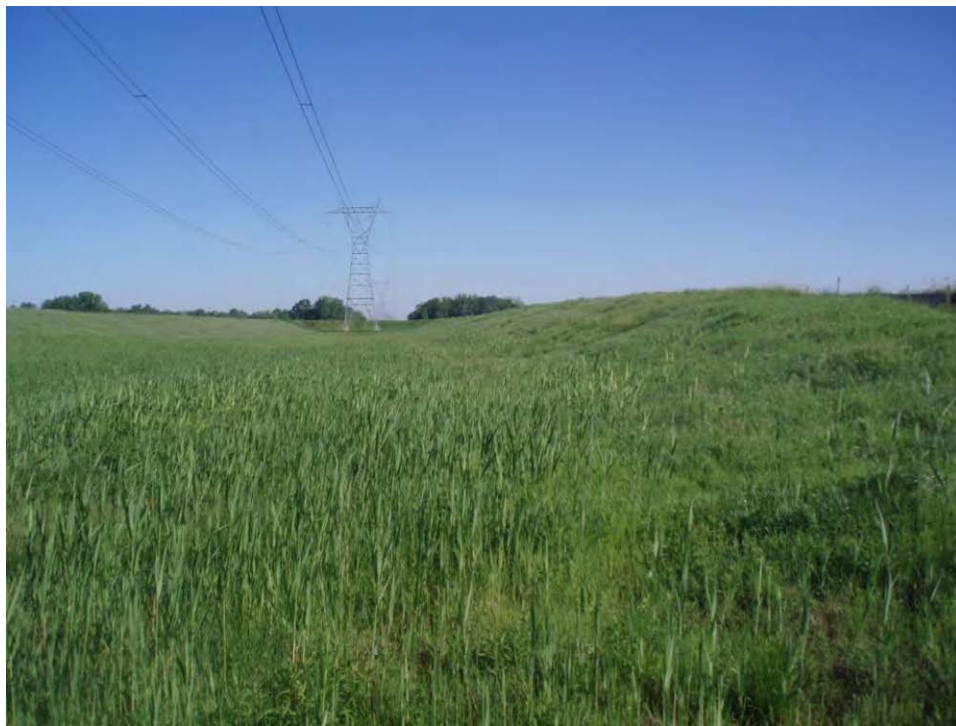
131. Overview of area between Pond B and Pond C, looking northwest. Note area between embankments is the top of the original impoundment.

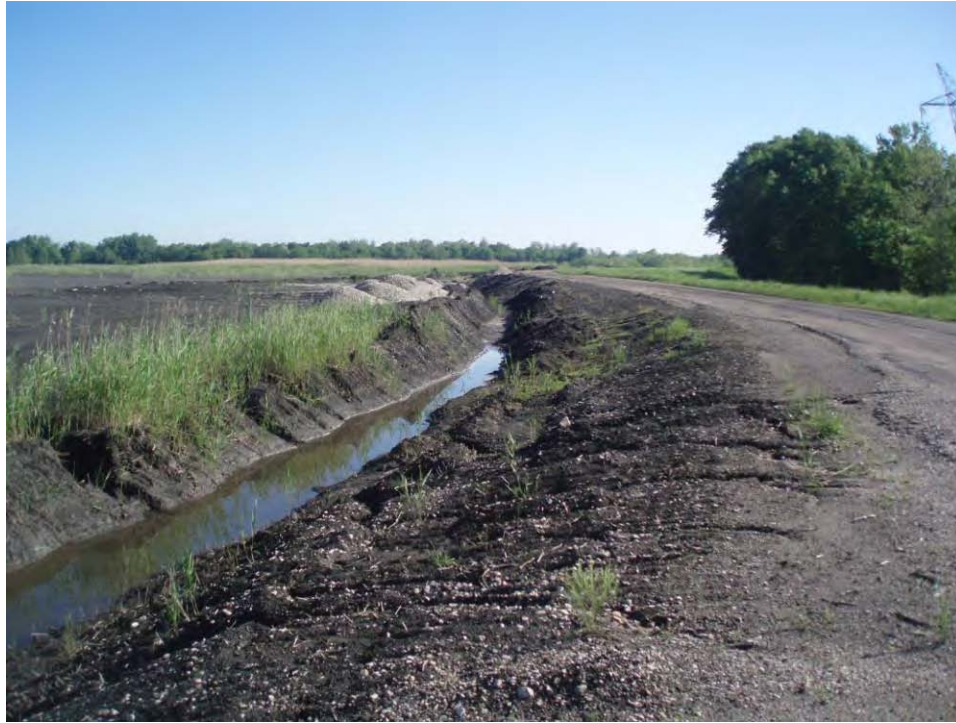
133. Pond C - East embankment interior slope, looking north at rim ditch to outlet structure.

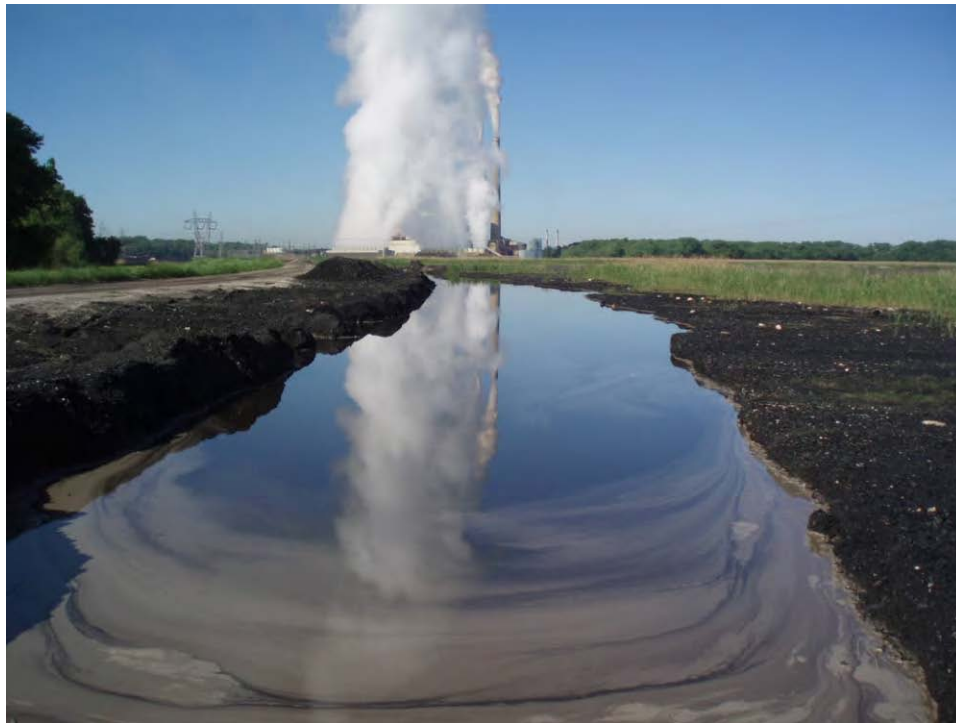
134. Pond C - East embankment interior slope, looking southwest at rim ditch to outlet structure. Note water level 3' below crest.

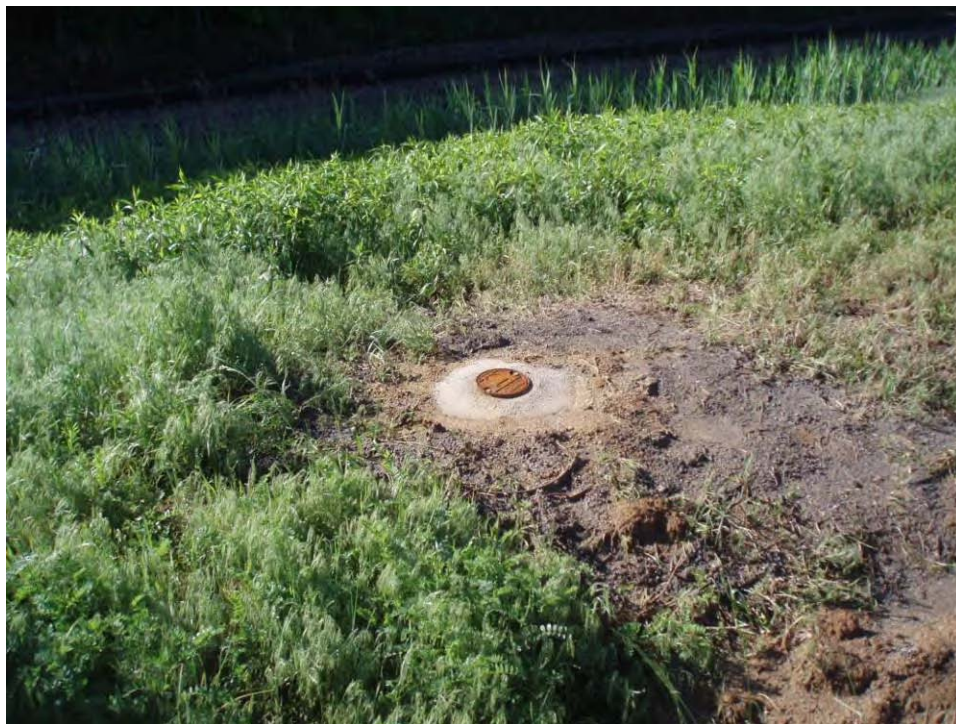
135. Pond C – East crest, looking at monitoring well installed by BT<sup>2</sup> on 4/23/10.

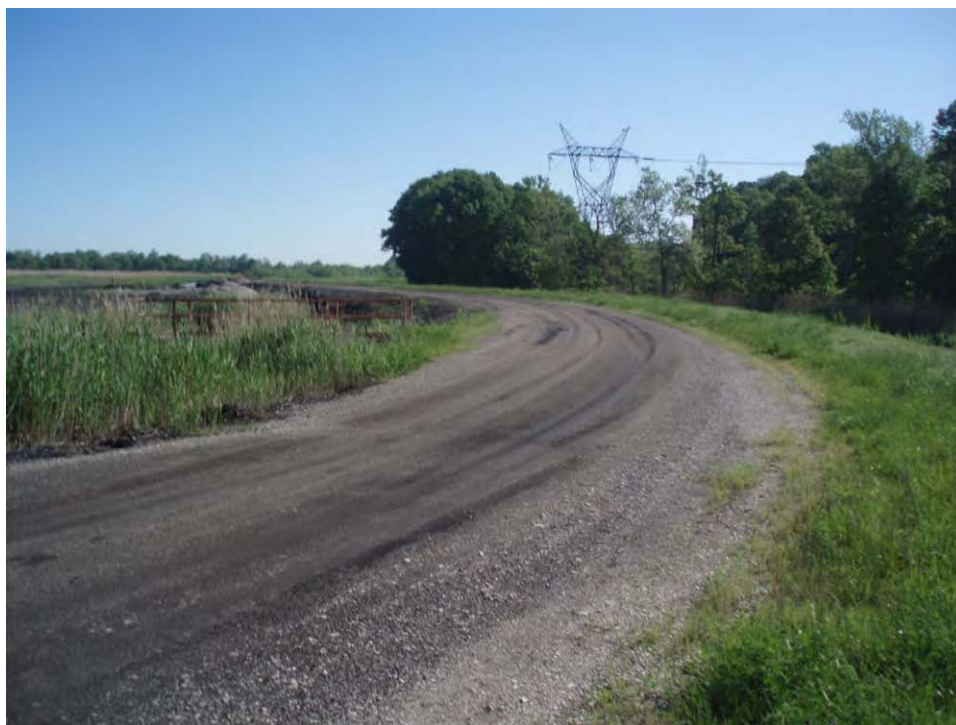
136. Pond C – East embankment crest, looking northeast.

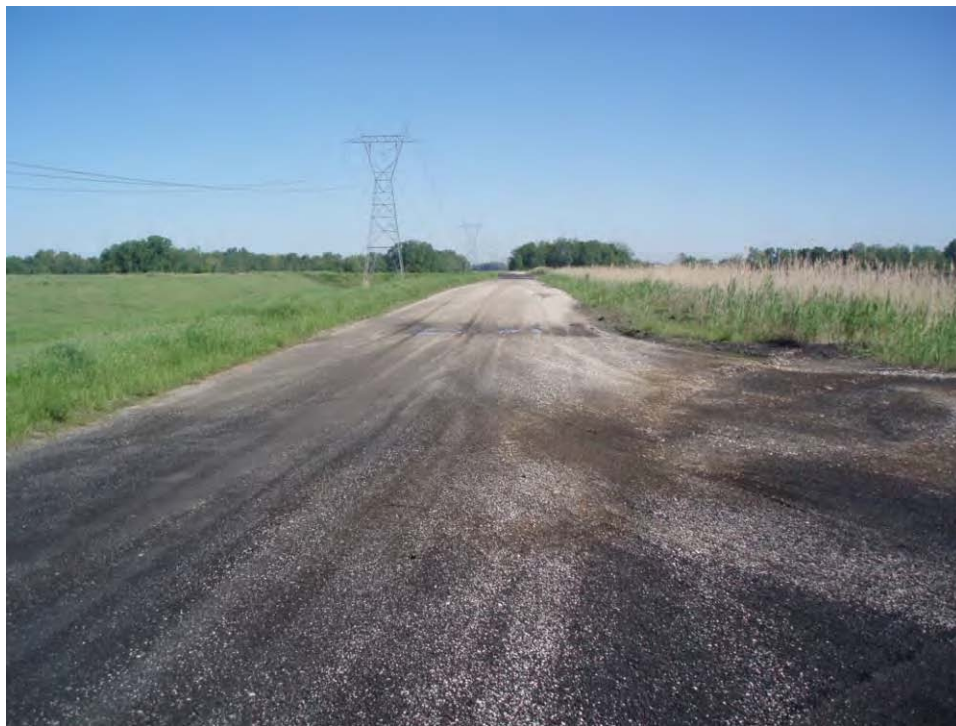
137. Pond C – South embankment crest, looking northwest.

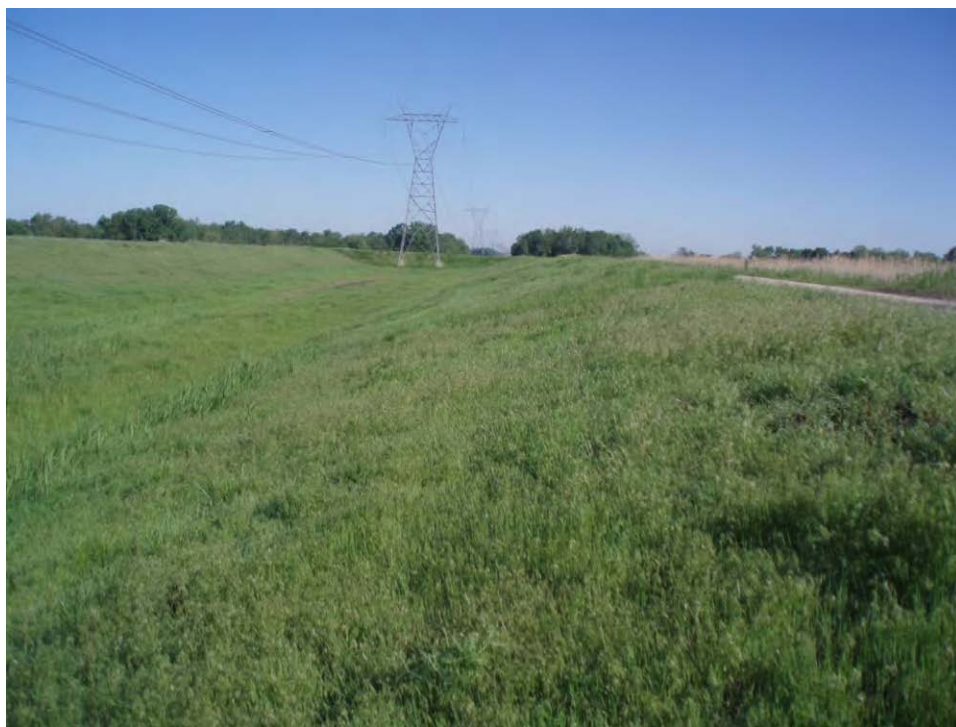
138. Pond C – South embankment exterior slope, looking northwest at area between Pond B and Pond C.

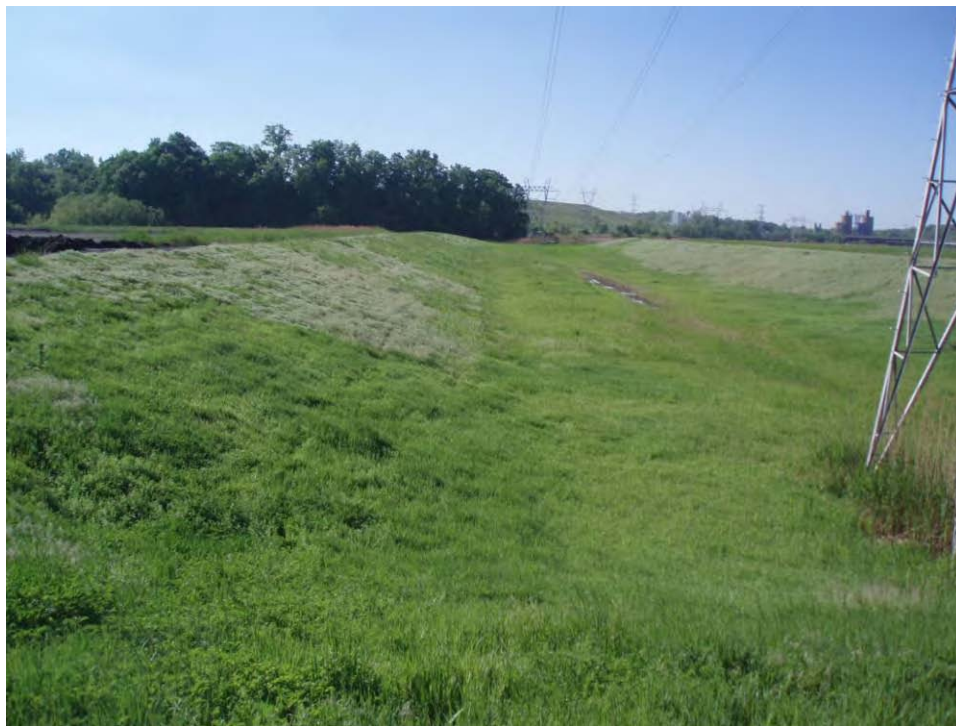
139. Pond C – South embankment exterior slope, looking southeast at area between Pond B and Pond C.

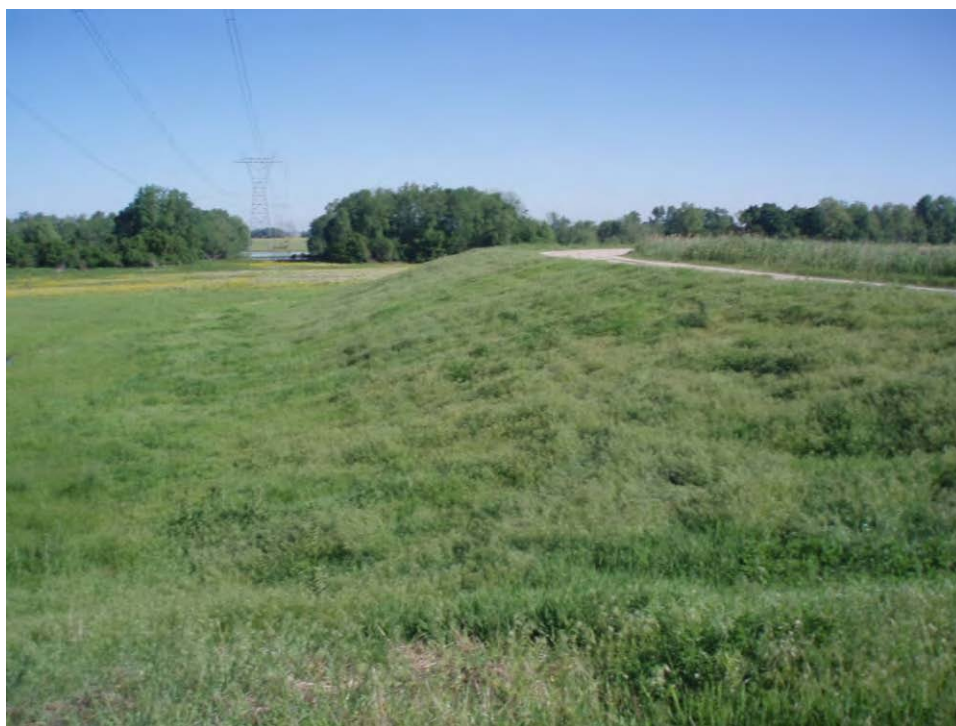
140. Pond C – South embankment exterior slope, looking northwest.
